Indicative Fire Test

189970

UAP Limited

11th February 2010

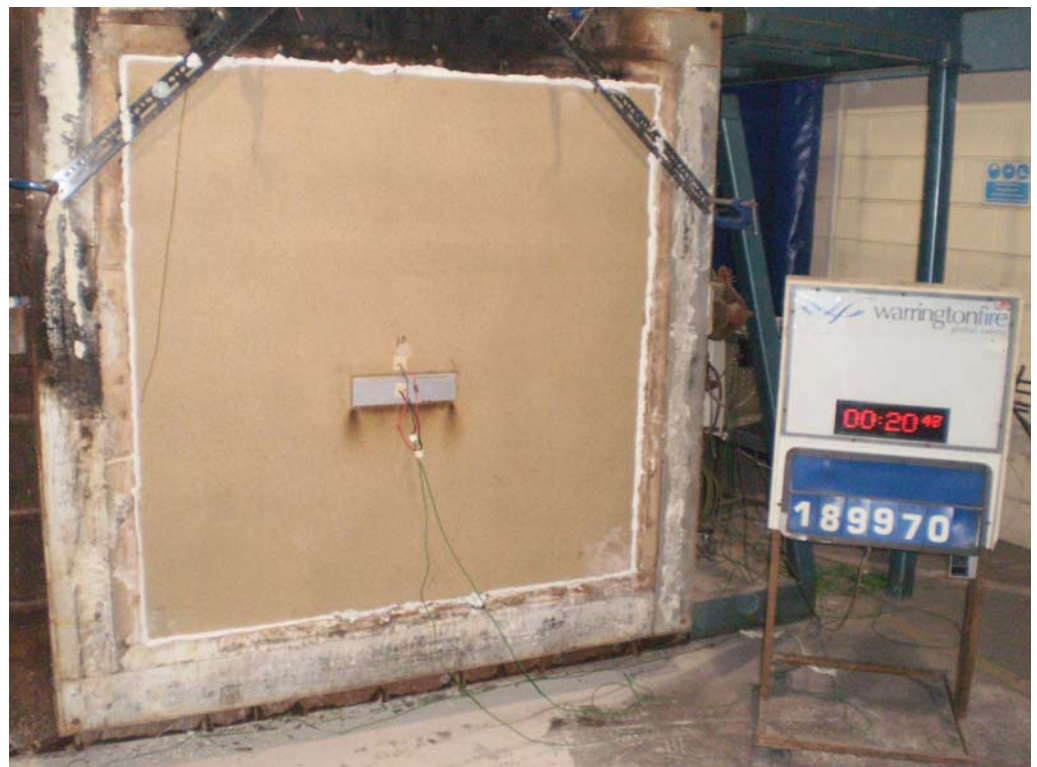
The unexposed face of the assembly after a test duration of 20 minutes

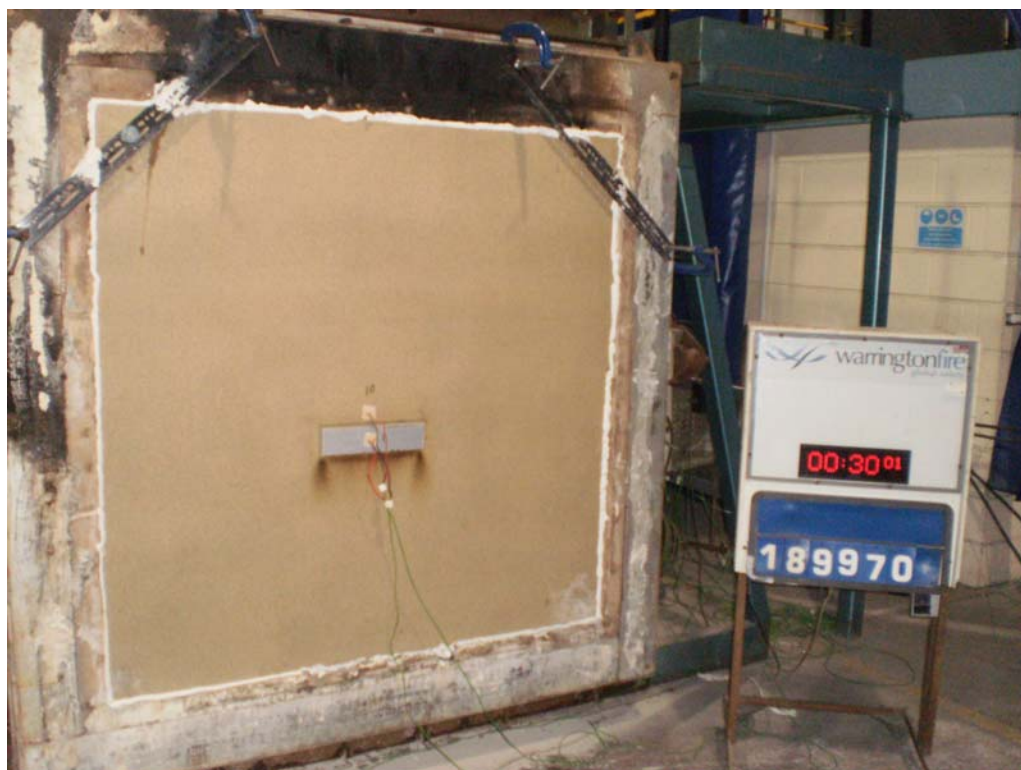
The unexposed face of the assembly after a test duration of 30 minutes

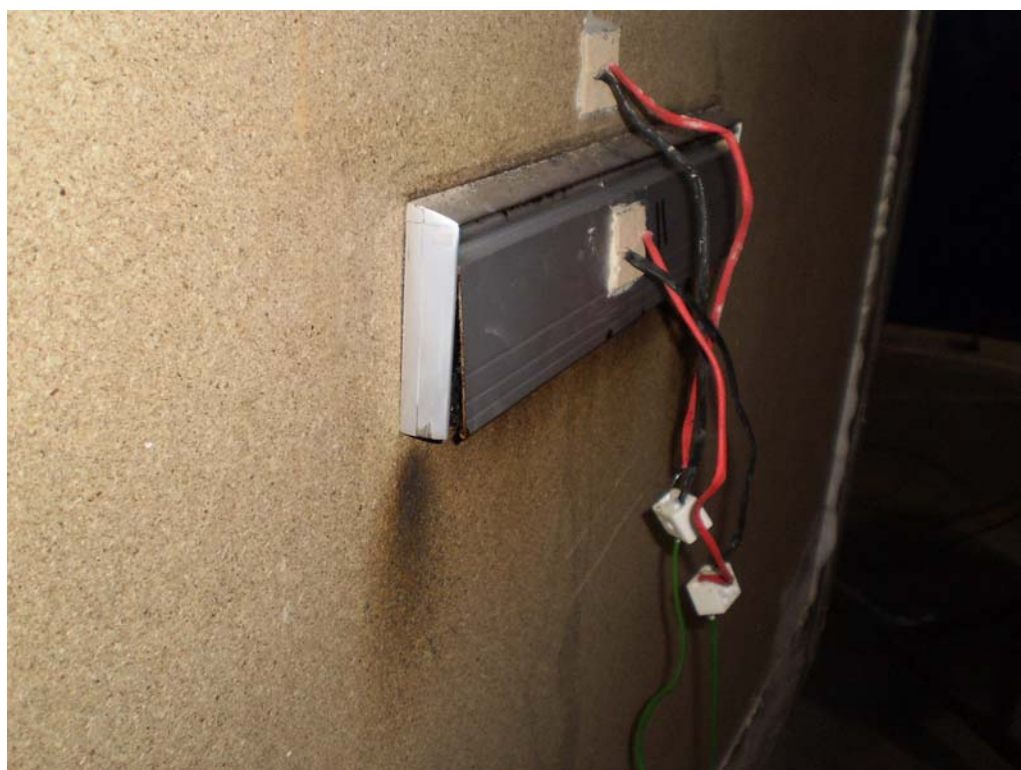
Time		All observations are from the unexposed face unless noted otherwise.
mins	secs	The ambient air temperature in the vicinity of the test construction was 11°C at the start of the test with a maximum variation of 5°C during the test.
00	00	The test commences.
10	38	The exposed face of the door leaf has ignited.
11	34	Smoke release is visible along the bottom edge of the letterplate with some moisture staining visible on the face of the door leaf adjacent to the bottom two corners of the letterplate.
16	00	Flaming can be seen around the exposed letterplate.
21	00	Little or no smoke release is visible around the letterplate.
30	00	No significant visible change to the unexposed face.
34	05	The exposed face of the door leaf is cracked and charred, it is difficult to make out the letterplate due to the flaming around the assembly.
54	16	The letterplate flap is starting to be pushed open slightly along the bottom edge.

The bottom edge of the letterplate flap starts to get pushed open with the reaction of the intumescent

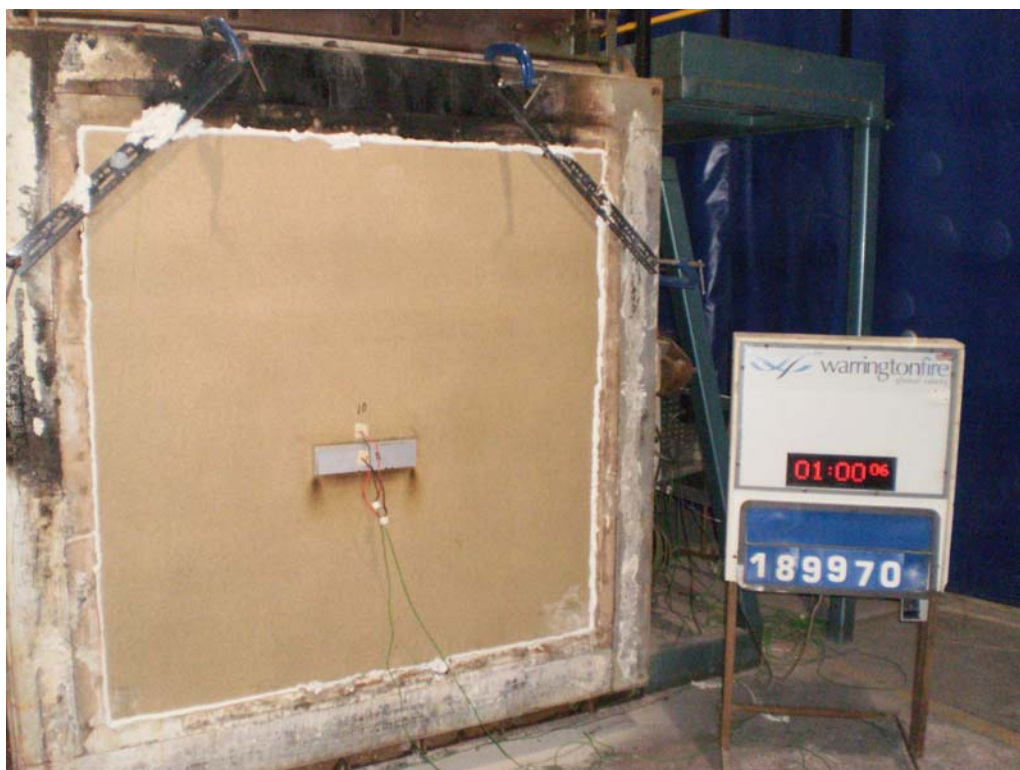
The unexposed face of the assembly after a test duration of 60 minutes

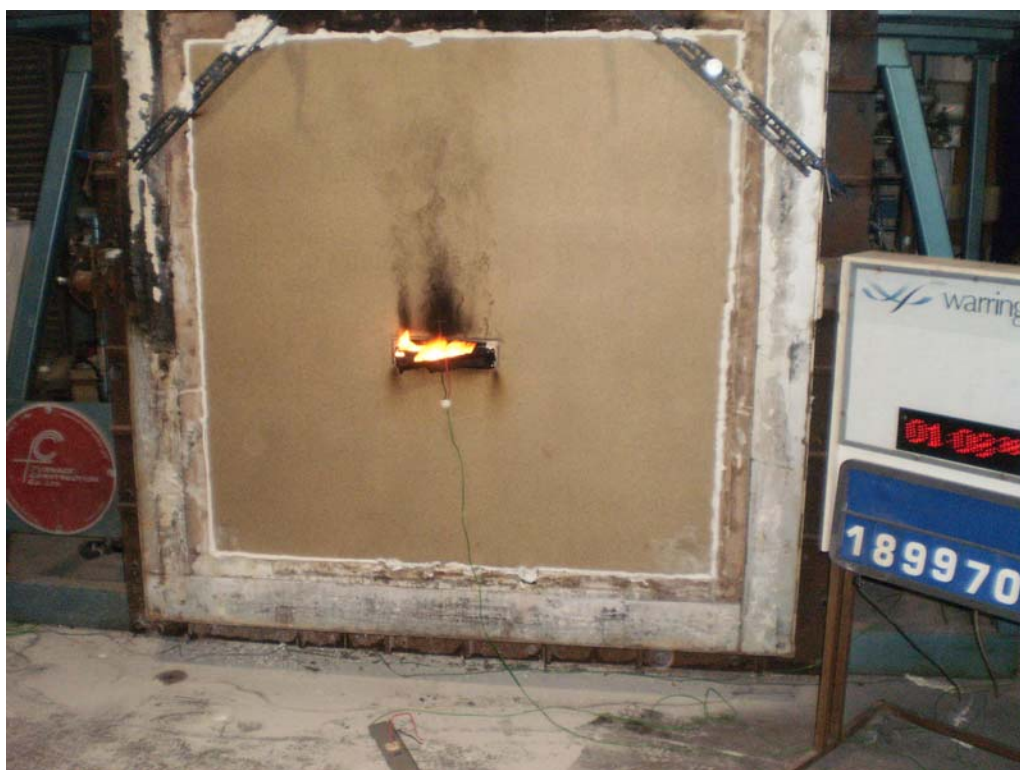
61	10	No significant visible change.
64	00	The face of the door leaf starts to vibrate.
67	00	Viewed from the exposed side a white material fills the aperture of the letterplate.
68	09	The letterplate flap falls away, flaming is visible from the letterplate void. The test is discontinued at the sponsor's request.

The unexposed face of the assembly after a test duration of 68 minutes

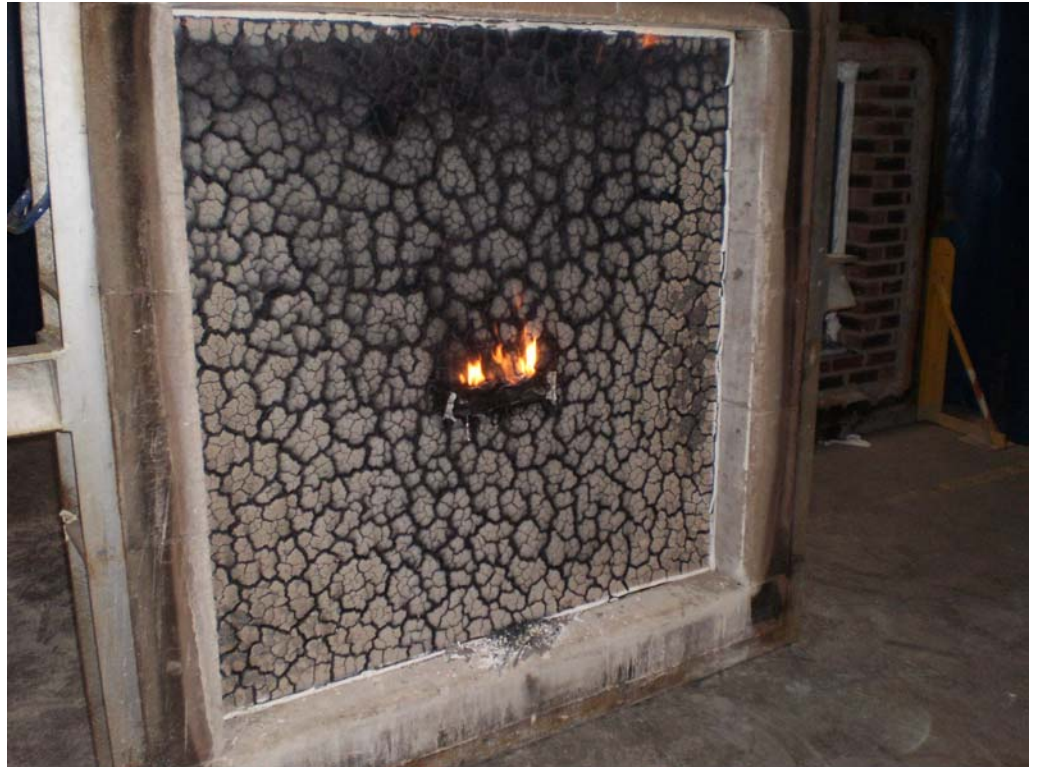
The exposed face
of the assembly
immediately after
the test
