Indicative Fire Test

189969

**UAP Limited**

11<sup>th</sup> February 2010

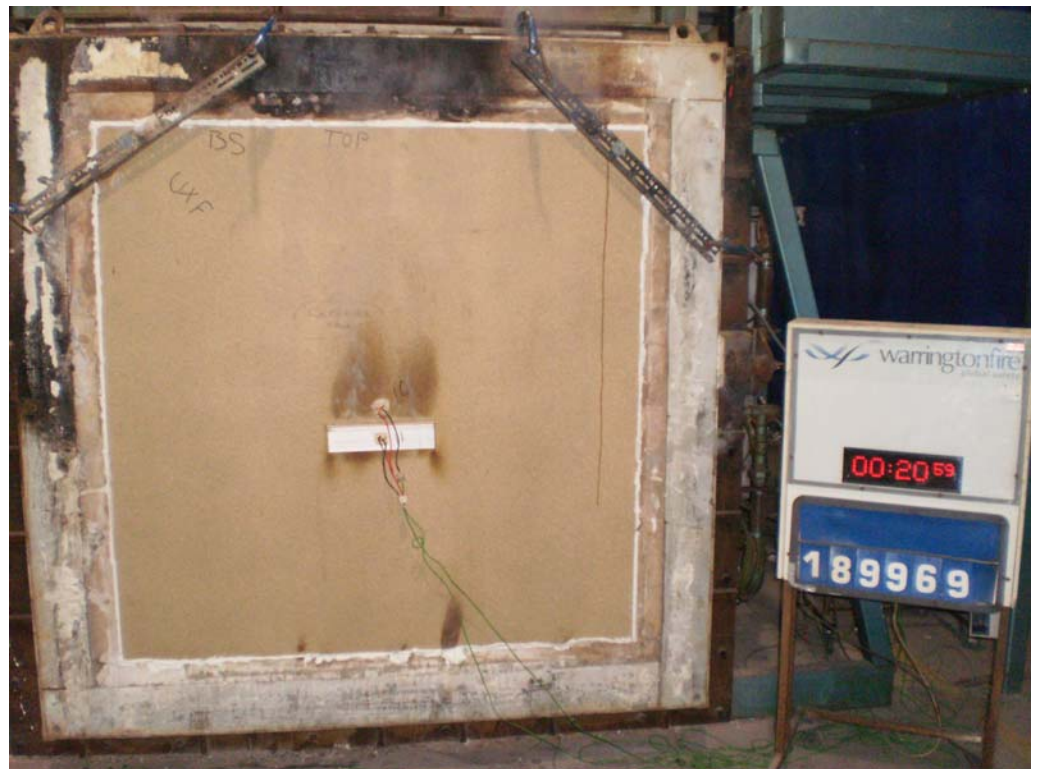
The unexposed face of the assembly after a test duration of 20 minutes

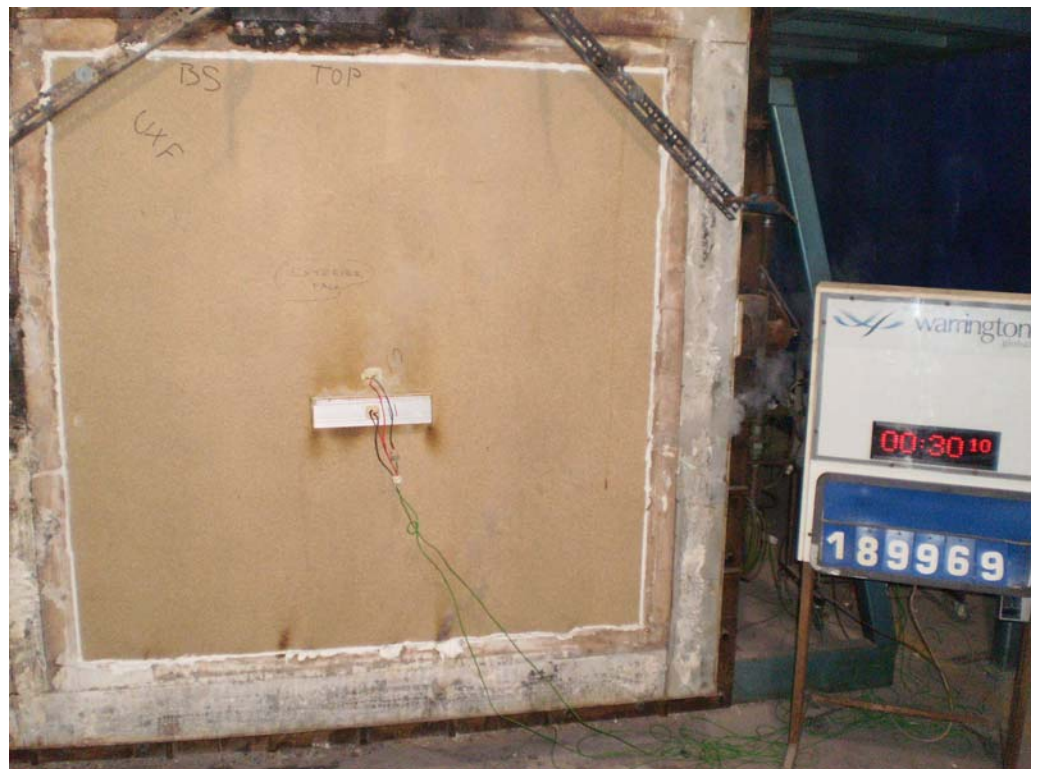
The unexposed face of the assembly after a test duration of 30 minutes

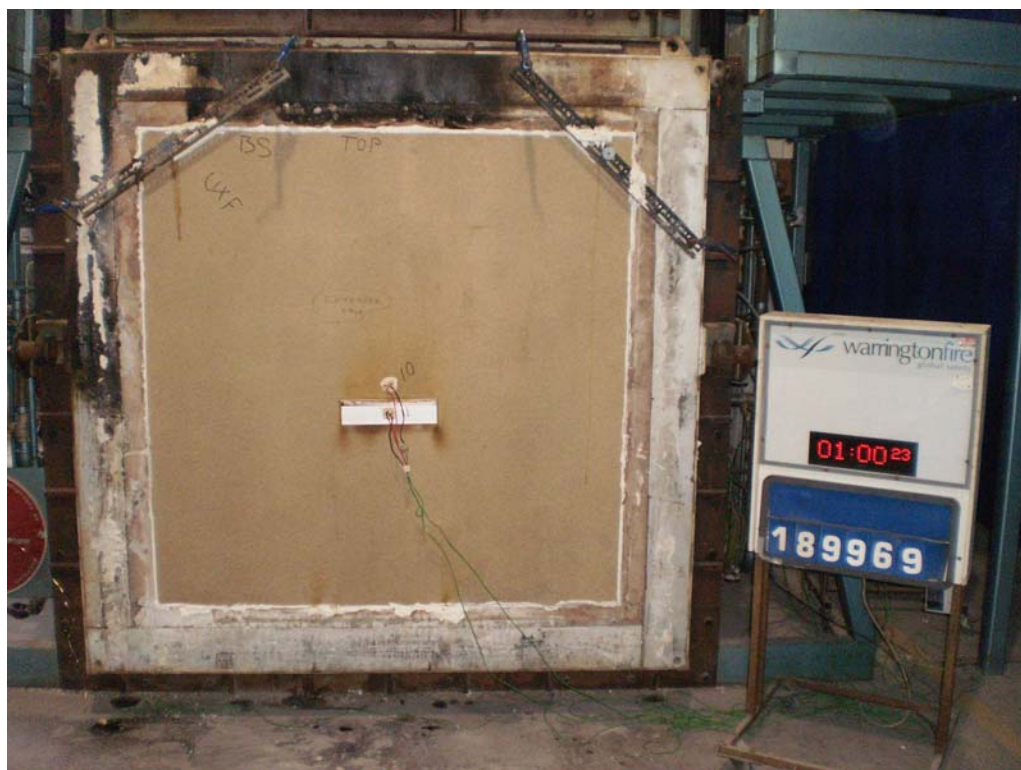
The unexposed face of the assembly after a test duration of 60 minutes

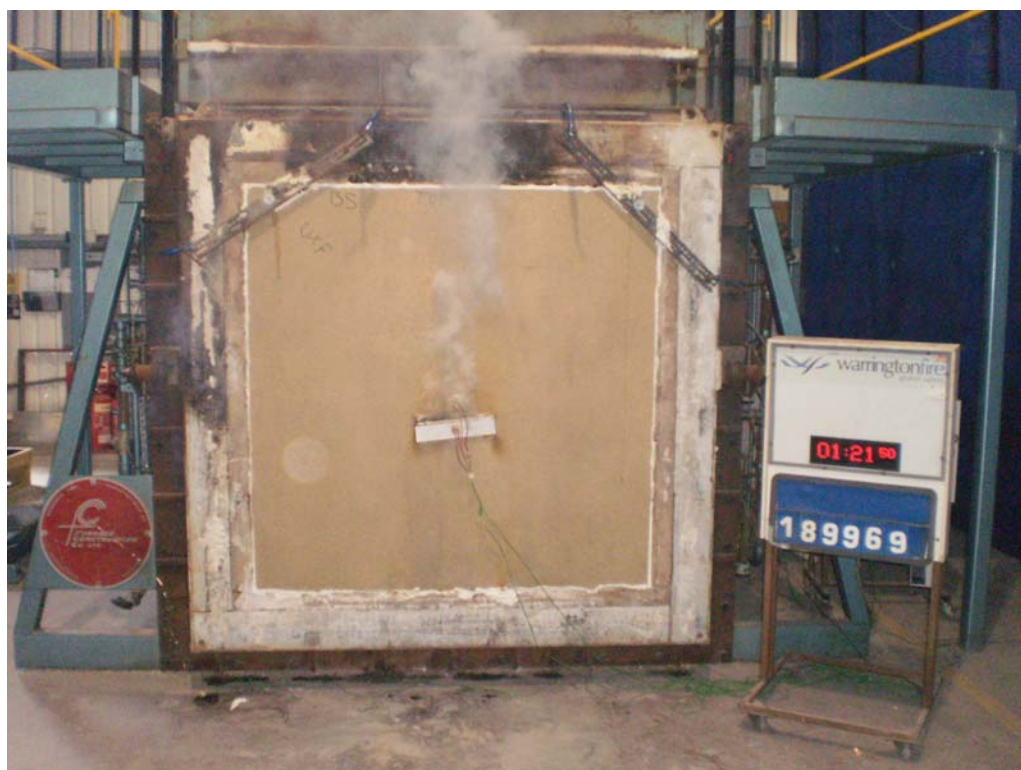
41	24	Only faint smoke release is now visible from the top edge of the letterplate. The letter plate remains flush to the door leaf
46	00	The door leaf starts to vibrate slightly.
58	07	Very little smoke release is now visible from the letterplate. A black/brown residue is visible across the top hinge/pivot on the unexposed face of the letterplate.
66	35	Viewed from the exposed side, a white material fills the aperture of the letterplate.
77	04	Smoke release now visible fro the bottom edge of the letter plate.
81	21	The left hand edge of the letterplate flap starts to slump down.
82	01	The letterplate flap falls away a through gap and flaming is now visible
82	20	<b>The test is discontinued at the sponsor's request.</b>

The unexposed face of the assembly after a test duration of 81 minutes

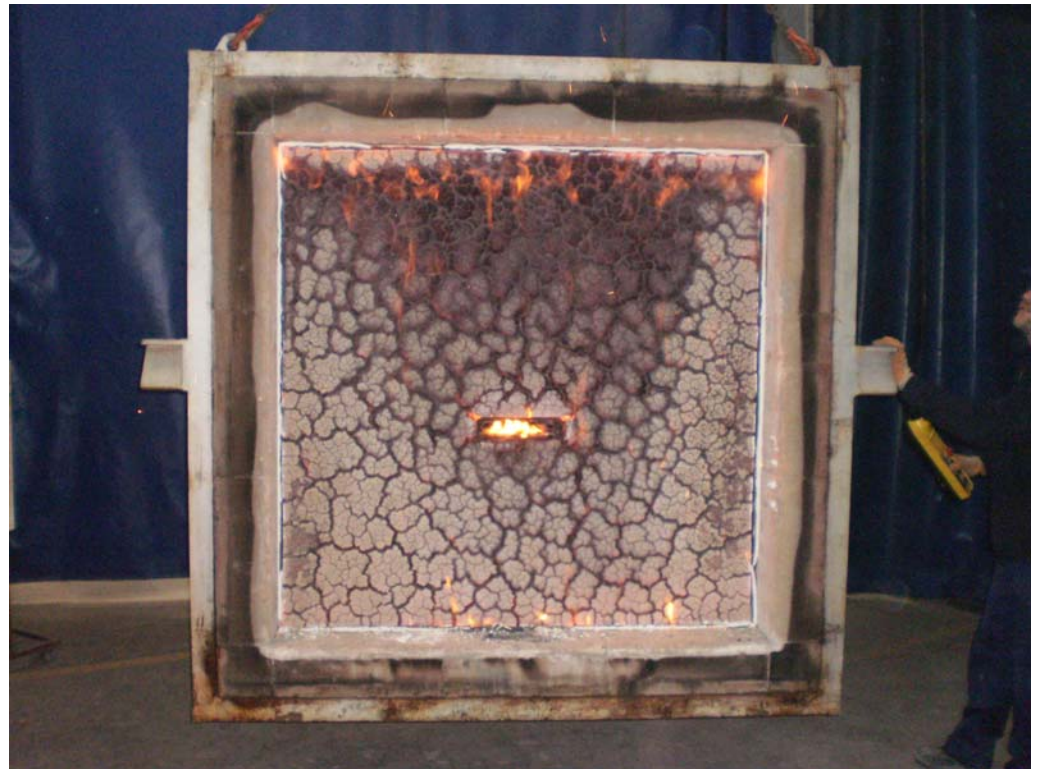
The exposed face  
of the assembly  
immediately after  
the test
